**Scoda Aeronáutica Ltda**  
Estrada Municipal IPN 020 km 0,1  
Ipeúna – SP, Brazil.  
PHONE: (19) 3576-1292  
ZIP CODE: 13537-000  
[www.scodaeronautica.com.br](http://www.scodaeronautica.com.br)

**SB\_SPXP\_010**  
**Revision 00**

## SB\_SPXP\_010 Engine Cooling Baffle

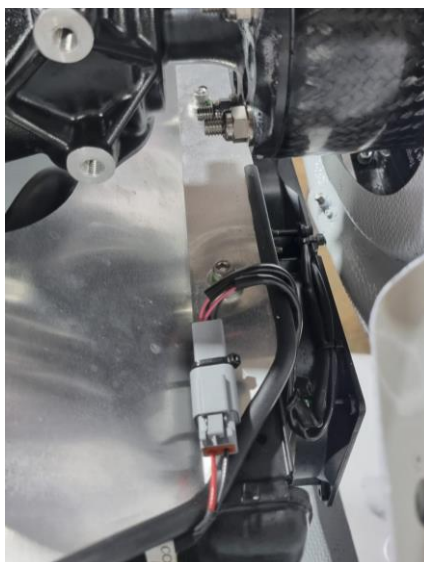
**Improper installation of grommets and loose wiring harnesses may compromise the functionality of the cooling fans system.**

- c) Install the baffle and fix it using the bolts, washers and bushings.
- d) Check the electrical wiring of the cooling fans is not running across the sharp edges of the baffle. Isolate the wiring from the baffle by installing the grommet in the sharp edge.

- e) Check the gap between the fiber baffles of the lower cowlings and aluminum baffle. If necessary, adjust the fiber baffle by sanding.
- f) Reinstall the engine cowlings and check the baffle for position and gap with the upper engine cowling.
- g) Make the following logbook entry:
