**Scoda Aeronáutica Ltda**  
Estrada Municipal IPN 020 km 0,1  
Ipeúna – SP, Brazil.  
PHONE: (19) 3576-1292  
ZIP CODE: 13537-000  
[www.scodaeronautica.com.br](http://www.scodaeronautica.com.br)

**SB\_SPXP\_010**  
**Revision 00**

## SB\_SPXP\_010 Engine Cooling Baffle

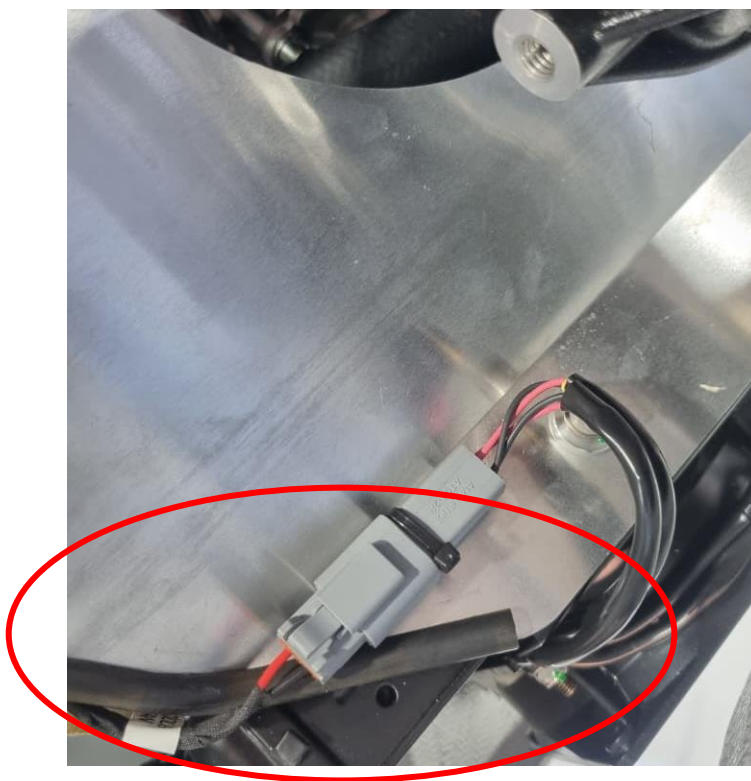
Improper installation of grommets and loose wiring harnesses may compromise the functionality of the cooling fans system.

- c) Install the baffle and fix it using the bolts, washers and bushings.
- d) Check the electrical wiring of the cooling fans is not running across the sharp edges of the baffle. Isolate the wiring from the baffle by installing the grommet in the sharp edge.
