NOTIFICATION

NT_SPLS_008
Revision 01

FUEL INDICATION

Wing tank overfueling related problems

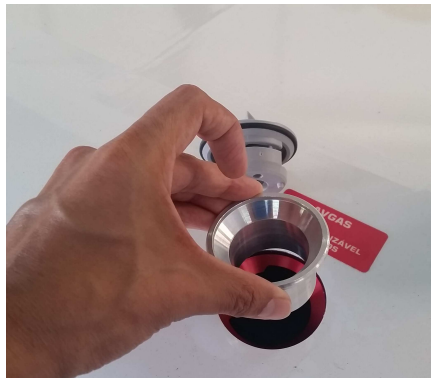
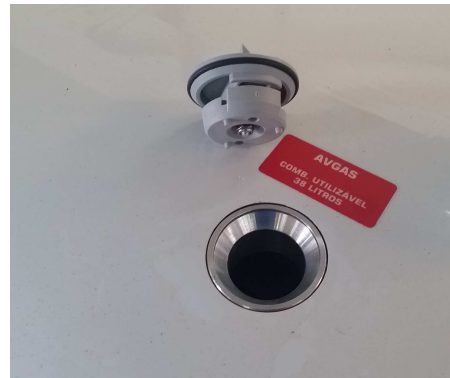
The use of a limiter as presented below may help preventing the wing tank to be overfueled.

- The aircraft should be leveled for fueling procedure.
- Fuel the wing tanks up to one inch (1 in) between fuel level and wing tank cap.
