SERVICE INSTRUCTION

SI_SPLS_002
Revision 02

FUEL SENSOR UNIT REPLACEMENT

Type:	Super Petrel
Model:	LS
Serial Number:	All serial number
Applicable Countries:	Not Limited

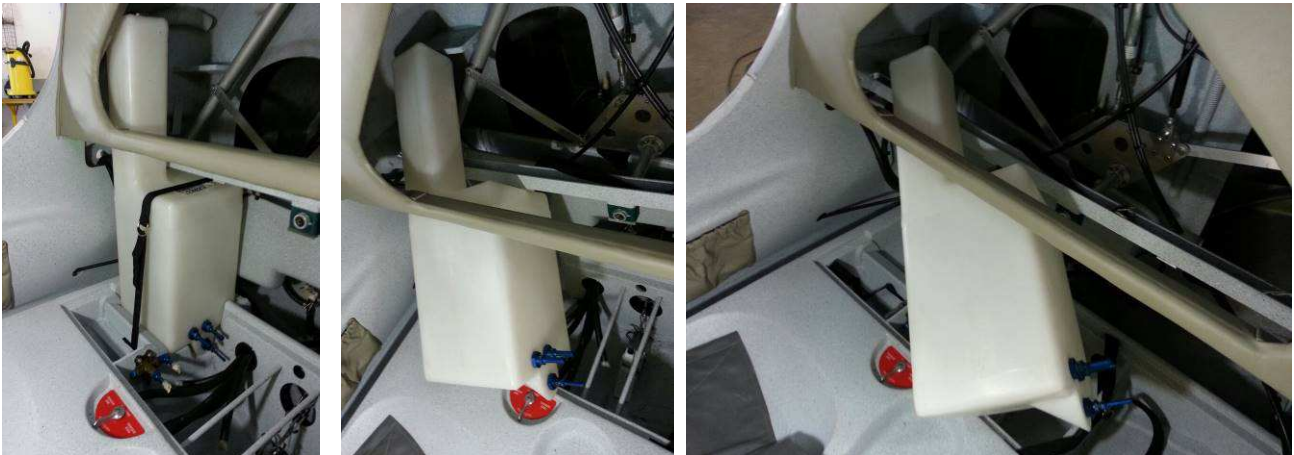
4. Remove clamps to disconnect hoses from the header tank.
5. Disconnect wires from the fuel sensor.
6. Remove the header tank fixation brand and then remove the header tank.

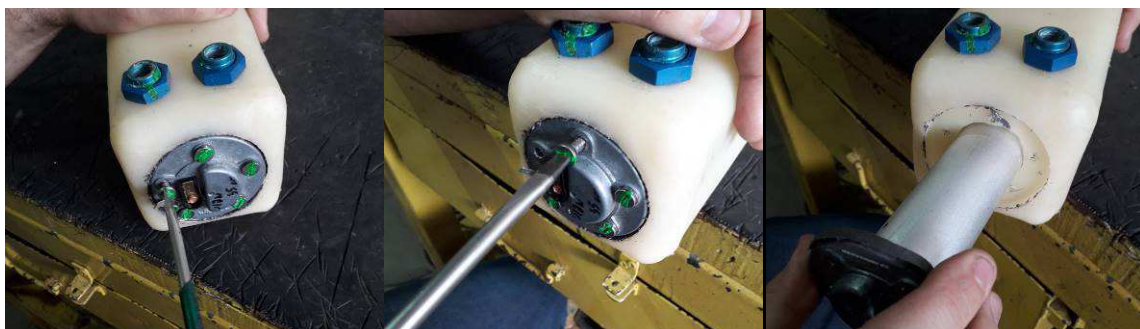
7. Remove the fuel sensor.

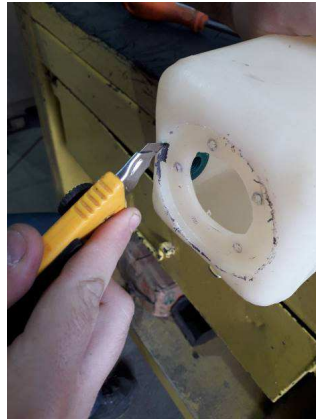
8. Clean the PRC from the header tank top surface.

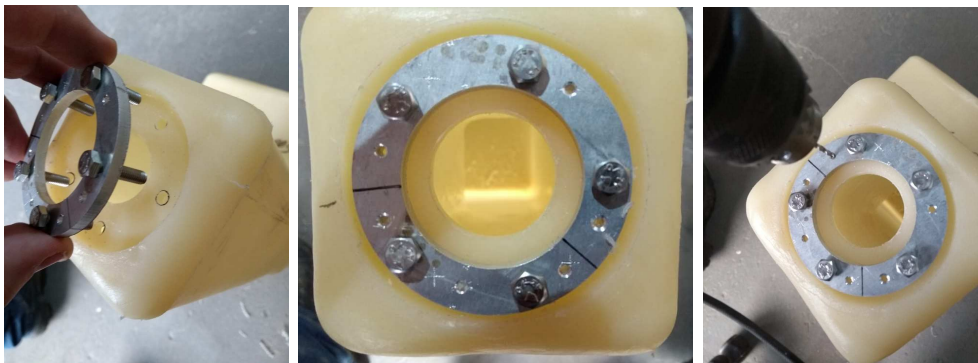
9. Install the support plate on the header tank. Drill the top surface with 3/32 inches in order to install the rivets.

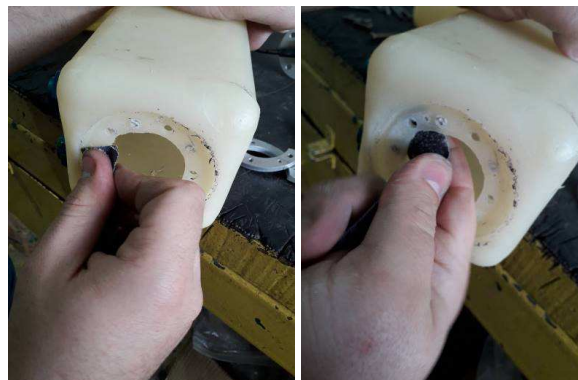
10. Clean the external and internal surface of the header tank using a sand paper 100.

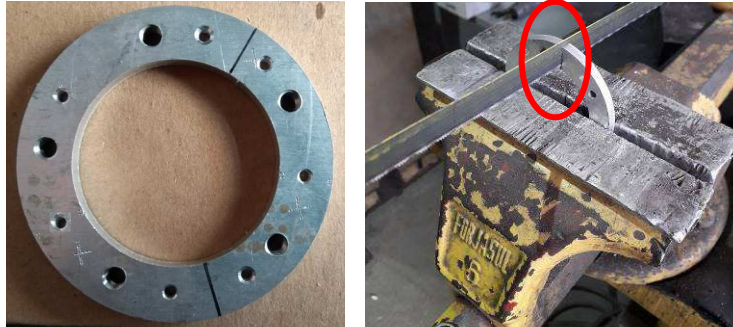
11. Cut the support plate following the marks. Use a hacksaw.

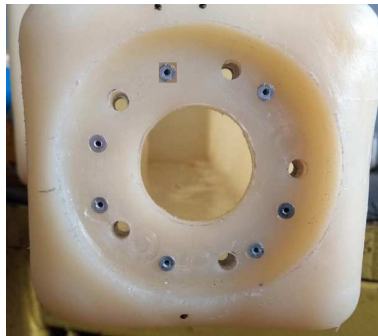
12. Install the halves of the support plate in the internal part of the header tank top using the fixation bolts. Then install the rivets.

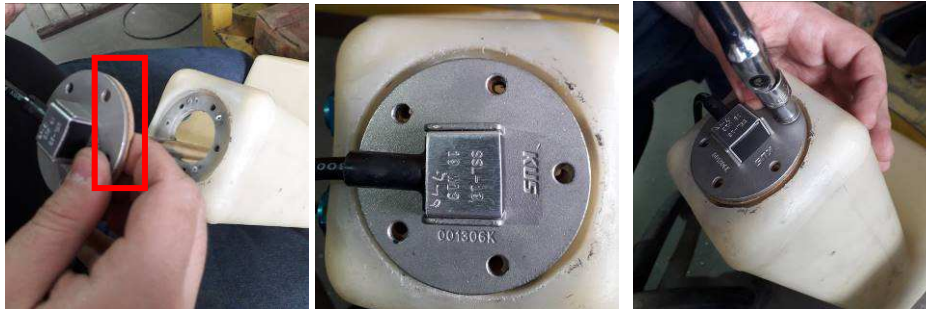
15. Install the fuel sensor with the cork gasket. Apply Loctite 577 on the bolts and torque with 35 lbf.in. / 4 N.m.

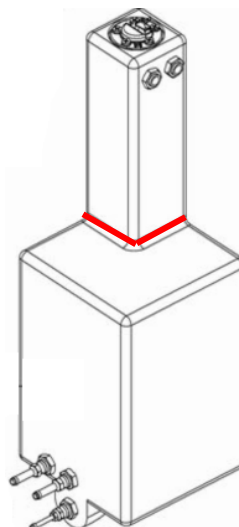
16. Install electrical connectors on the new fuel sensor. Black wire of the new fuel sensor connects to the stripe white and blue of the aircraft.
17. Reinstall the header tank on the aircraft. Make sure all hoses, clamps and wires are properly connected.
18. Open Shut Off valve.
19. Select the wing tank with less quantity and wait until fuel level equalizes.
20. Level the aircraft laterally.
21. Set fuel level 10 mm above the shoulder of the header tank (reference for zero fuel on the selected wing tank).
