SAFETY ALERT

SA_SPLS_001
Revision 02

INSPECTION FOR APPLICABILITY OF ROTAX ASB-912I-011iS

Replacement of fuel pump assy. for ROTAX Engine Type 912 i (Series)

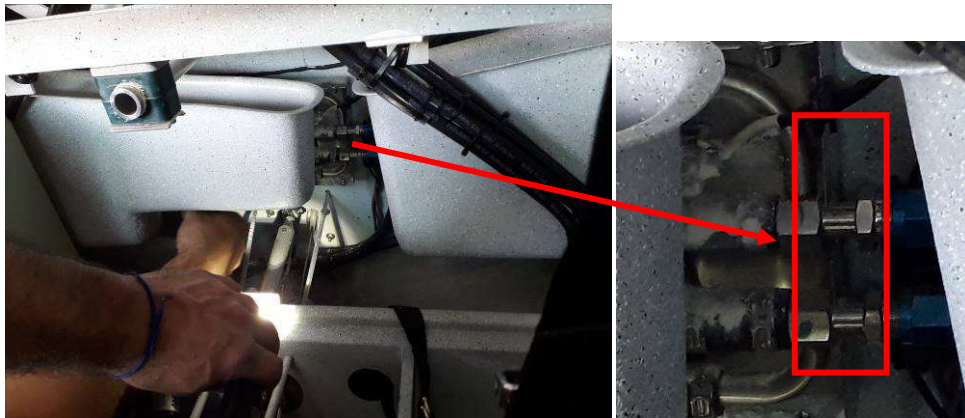
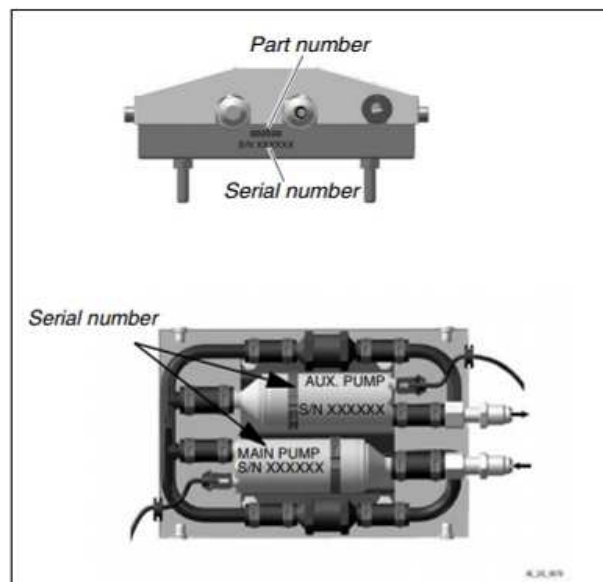
1. Remove the baggage compartment.
2. The fuel pump assembly is located behind the baggage compartment fixed on the main bulkhead.
3. Check the serial number of the fuel pump assembly. If the fuel pump is affected, please follow the instructions of the Rotax Alert Service Bulletin.
