SERVICE INSTRUCTION

SI_SPLS_006
Revision 01

Leakage Repair – Wing Fuel Tank

Type:	Super Petrel
Model:	LS
Serial Number:	All
Applicable Countries:	Not Limited

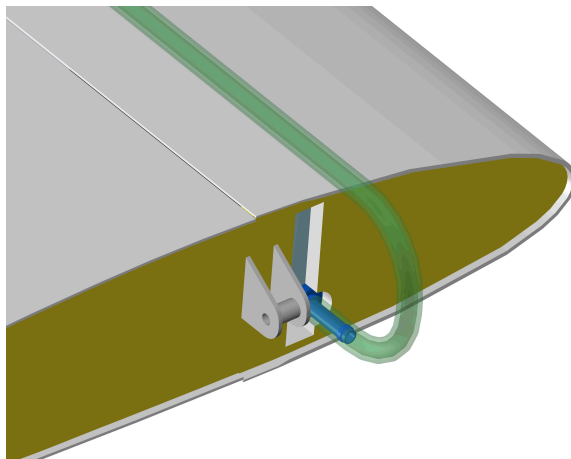
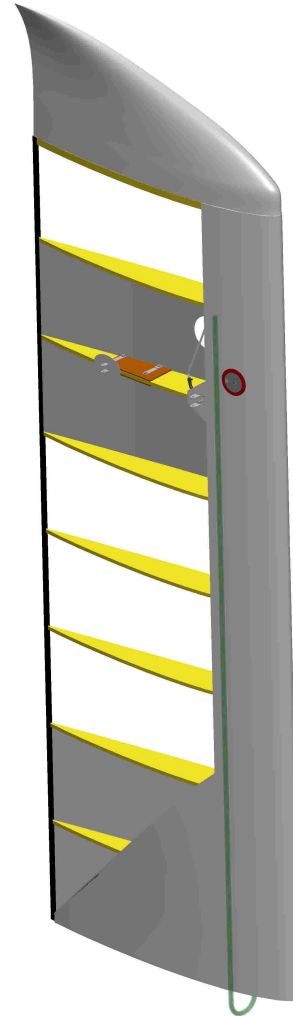
6. As soon as the leakage is identified, check the fuel level in the transparent hose. The damage area (leakage point) is just below the fuel level.
7. In order to identify if the leakage location is in the lower surface, tilt the wing back and check if is leaking in the fuel tank output.

4. Connect a transparent hose in the fuel output of the wing and place over the leading edge up to the filler cap (upper surface). The wing need to be vertically over a support.

5. Add 1 US Gal at a time and check for leakage in the fuel tank output.
