## SERVICE BULLETIN

**SB\_SPXP\_011**

## Canopy Guide Pin Inspection

Canopy guide pin preflight inspection and maintenance.

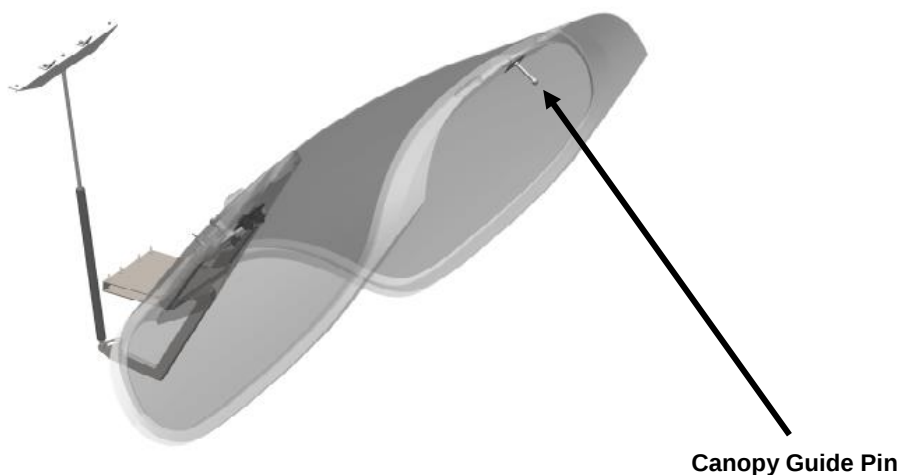
The owner / pilot must inspect the canopy guide pin for general condition during the preflight inspections.

The canopy guide pin must be inspected during maintenance events following the instructions described in the latest revision of the Super Petrel XP maintenance manual (Canopy Inspection Section).

Loctite 221 must be reapplied every time the guide pin is removed, replaced or adjusted.
