SERVICE BULLETIN

SB_SPLS_015

ENGINE OIL DECAL

Type:	Super Petrel
Model:	LS
Serial Number:	All
Applicable Countries:	All

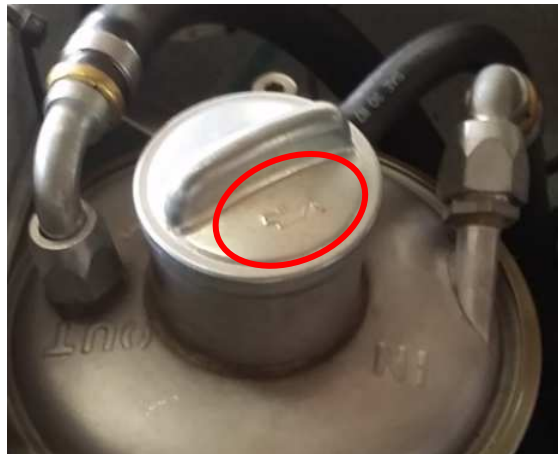
The Rotax oil tank cap has an icon printed in order to indicate engine oil (see picture below).

However based on field reports and in the continuous optimization of quality and safety an engine oil decal installation on the upper engine cowling has been introduced.

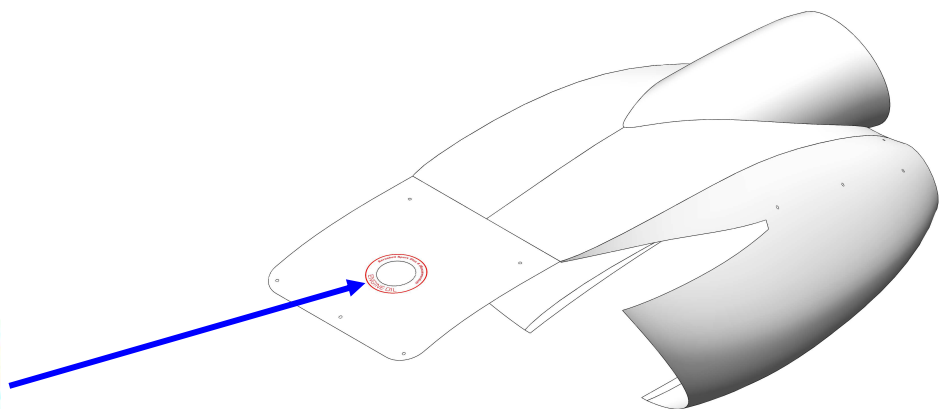
1. Engine oil decal should be installed on the upper engine cowling (see picture below).

Clean the surface of the engine cowling before installing the decal.
