# **MAINTENANCE AND INSPECTION PROCEDURES MANUAL**

**FOR SUPER PETREL LS**

**SCODA Aeronáutica LTDA.**  
**Estrada Municipal IPN 020, Km 0,1**  
**Ipeúna – SP, Brazil**  
**ZIP CODE: 13537-000**  
**(19) 3576-1292**  
**[www.scodaeronautica.com.br](http://www.scodaeronautica.com.br)**  
**[engineering@scodaero.com.br](mailto:engineering@scodaero.com.br)**

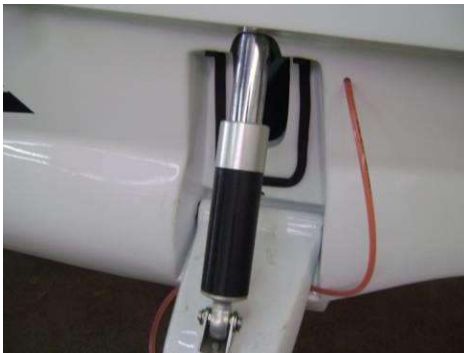
**Figure 5-40**

Shock absorber should be replaced on condition.

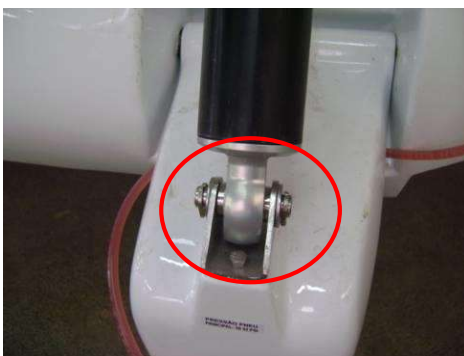
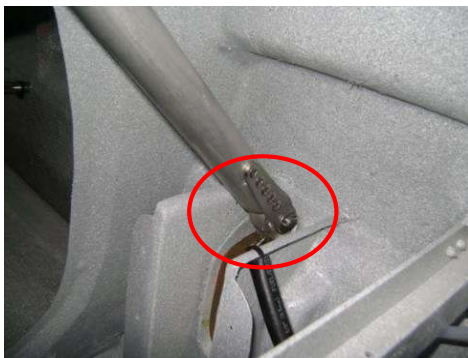
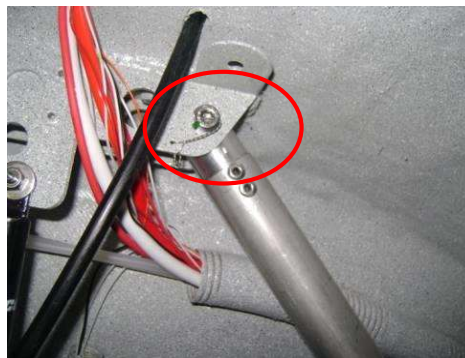
**Figure 5-41**

2. Attachment: use the flashlight if necessary

- Check the shock absorber attachment with the main gear leg and inside fuselage.

**a) Attachment with the main gear leg**

**b) Attachment inside the fuselage**

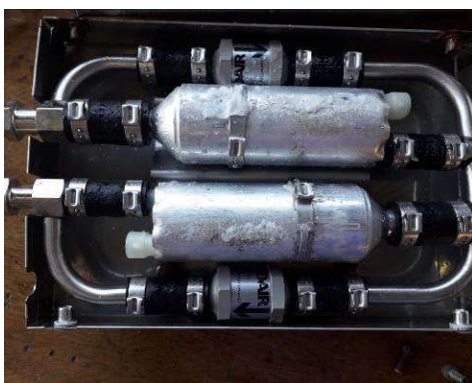
*Figure 5-74*

**IF THE ALUMINUM FUEL PUMP'S BODY PRESENTS CORROSION (SEE PICTURE BELOW), REPLACE THE FUEL PUMP IMMEDIATELY.**

Aircraft in operation on salt-water environment must have a recurrent corrosion inspection, cleaning and lubricating of the electric fuel pumps every 25 hours.
